**2005
PROJECT
STRUCTURE REPORT**

**INSPECTION OF
FLOOD CONTROL STRUCTURES ON THE
SACRAMENTO AND SAN JOAQUIN RIVERS
AND THEIR TRIBUTARIES**

**Prepared By
The Flood Operations Branch**

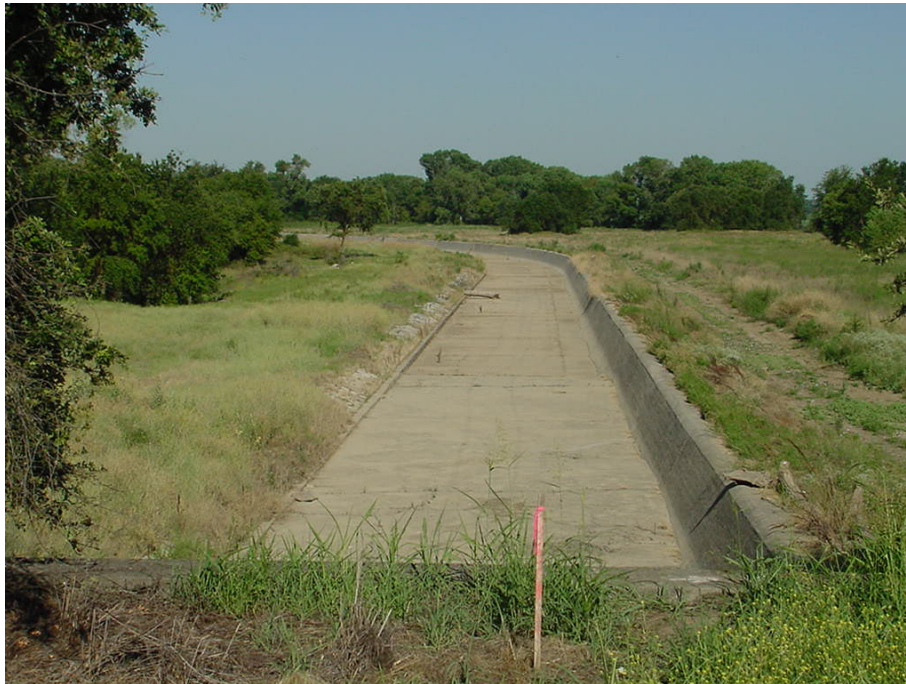
1. **Condition of concrete weir and stilling basin.**
 - a. **Some cracks and spalling exist on the weir and in the stilling basin as previously reported.**

View of the weir and stilling basin from the south abutment.

- a. **Good.**
7. **Comments:**
 - a. **Monitor the cracks and spalling and repair as needed.**
 - b. **Remove debris from the stilling basin prior to flood season.**

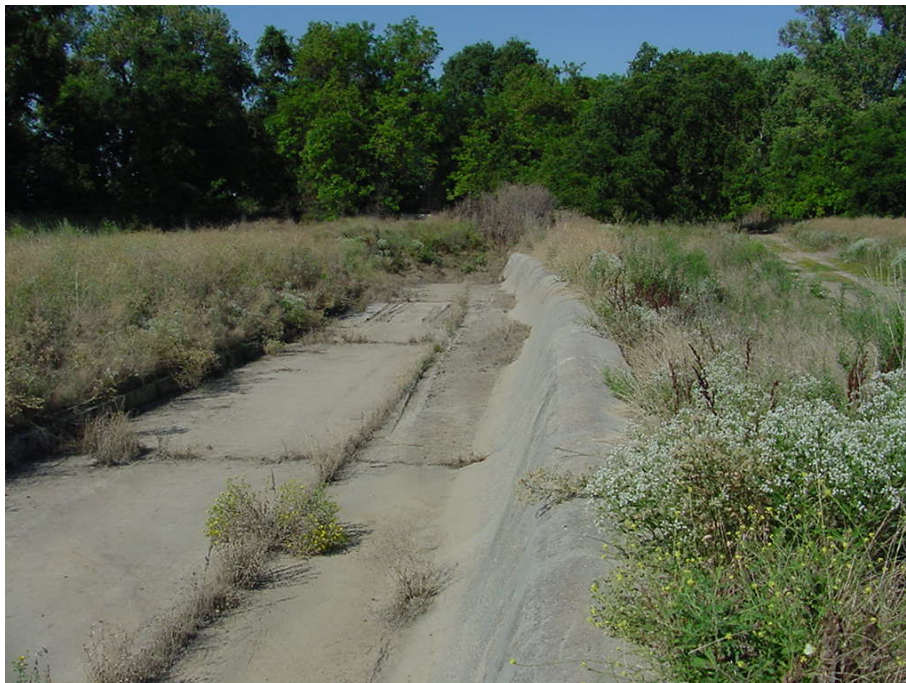
2. **Condition of concrete abutment.**
 - a. **Good.**
 - b. **The crack on the downstream side of the right (south) abutment, and the two cracks on the right abutment at Rattlesnake Island, have not enlarged.**

- c. **North abutment has large cracks on east side.**
3. **Condition of revetment.**
 - a. **Good.**
4. **Accumulation of trash and debris around the structure or in the channel.**

View of the weir, looking towards Rattlesnake Island.

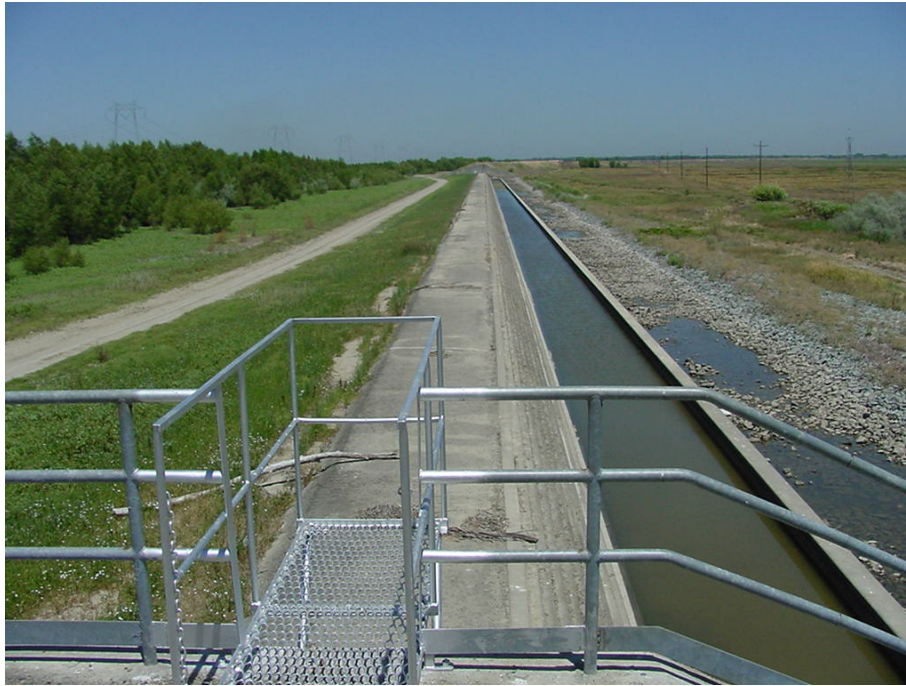
View of the weir and stilling basin.

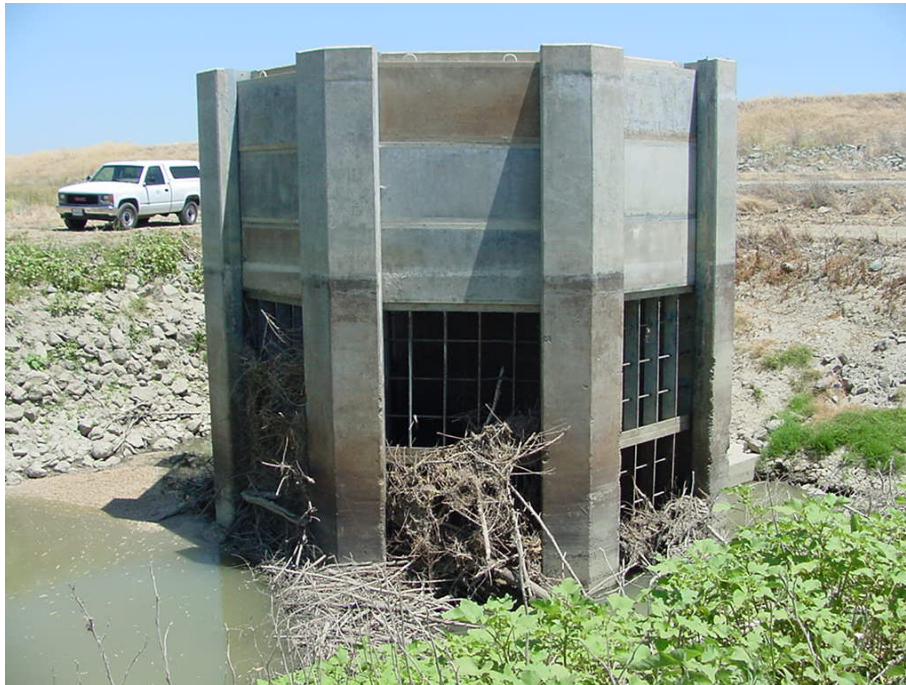
1. Condition of concrete weir structure and stilling basin.
 - a. Good.
2. Condition of drainage structure.
 - a. Good.
3. Condition of concrete abutments and wing walls.
 - a. Good.
4. Condition of revetment.
 - a. Good.
5. Accumulation of trash and debris around the structures or in the channels.
 - a. Debris has not yet been cleared from around the drainage structure.
6. Vegetation around the structures or in the channel.
 - a. None.
7. Comments:
 - a. Remove the accumulated debris around the drainage structure.
 - b. Good maintenance.

View of the drainage structure located in the southwest corner of the Cache Creek Settling Basin.

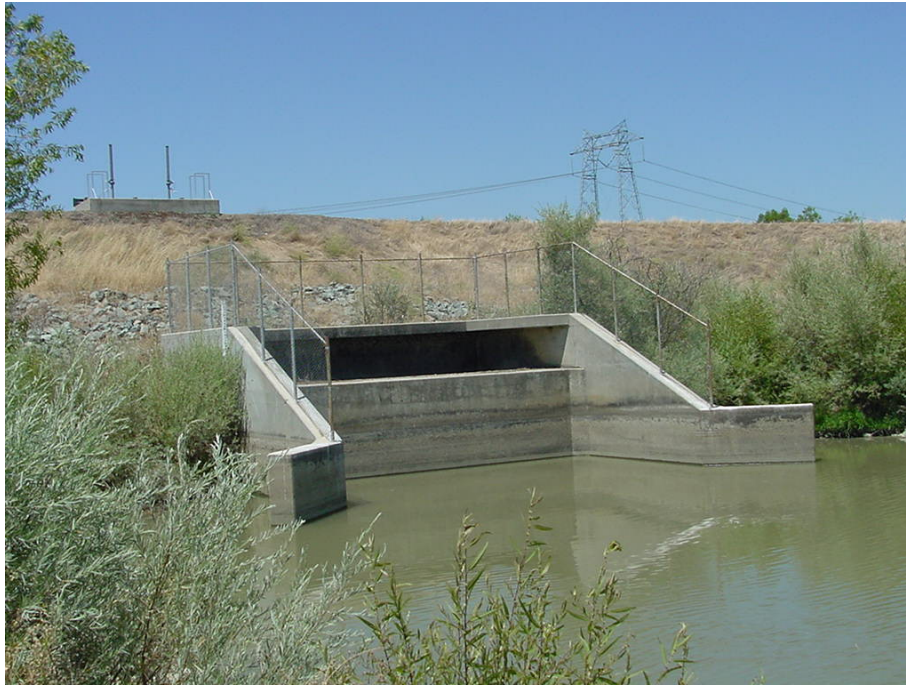
View of the outlet for the drainage structure.

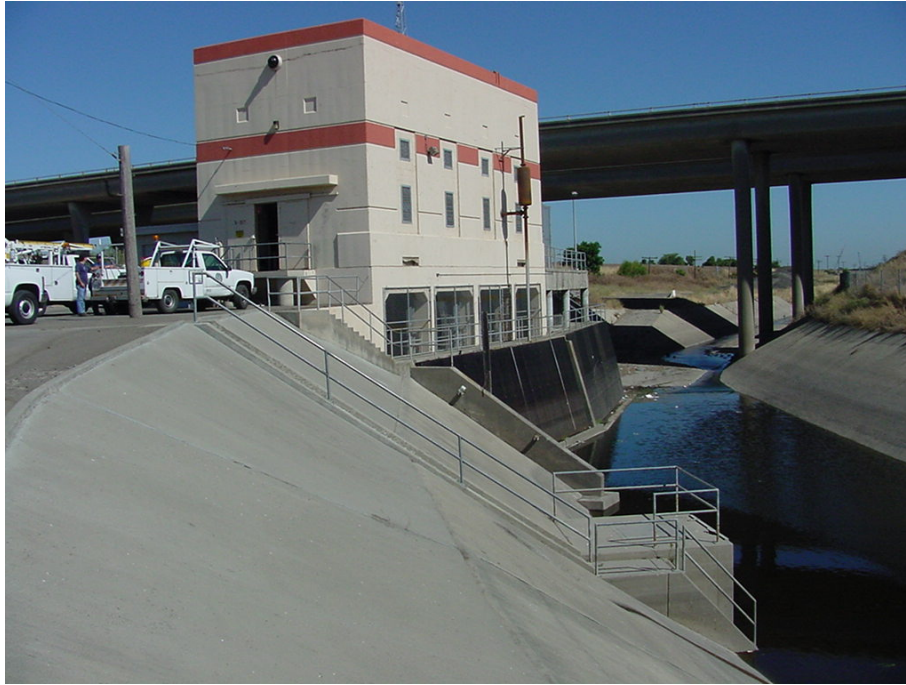
Pumping plant, sump, and trash racks at inlet, landward side from the left bank levee of the Natomas East Main Drain.

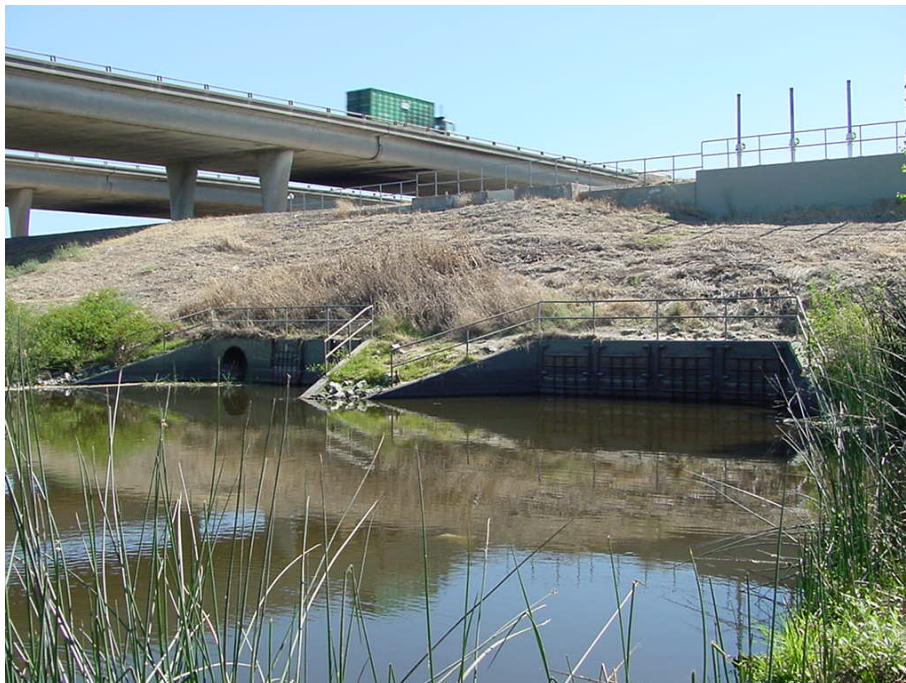
1. Condition of main pump structure.
 - a. Good.
2. Condition of abutment and wing walls.
 - a. Good.
3. Condition of the pumps and motors.
 - a. Good.
4. Condition of control gates, mechanisms, and flap gates.
 - a. Good.
5. Condition of the electrical equipment.
 - a. Good.
6. Condition of the trash racks.
 - a. Good.
7. Accumulation of trash debris in the sump or in the channel.
 - a. None.
8. Vegetation in the sump or in the inlet channel.
 - a. None.
9. Comments:
 - a. Good maintenance.
 - b. There are weekly, monthly and an annual inspection.
 - c. Replace flap gate.

Discharge end of structure on the water ward side from the left bank levee of the Natomas East Side Drain.

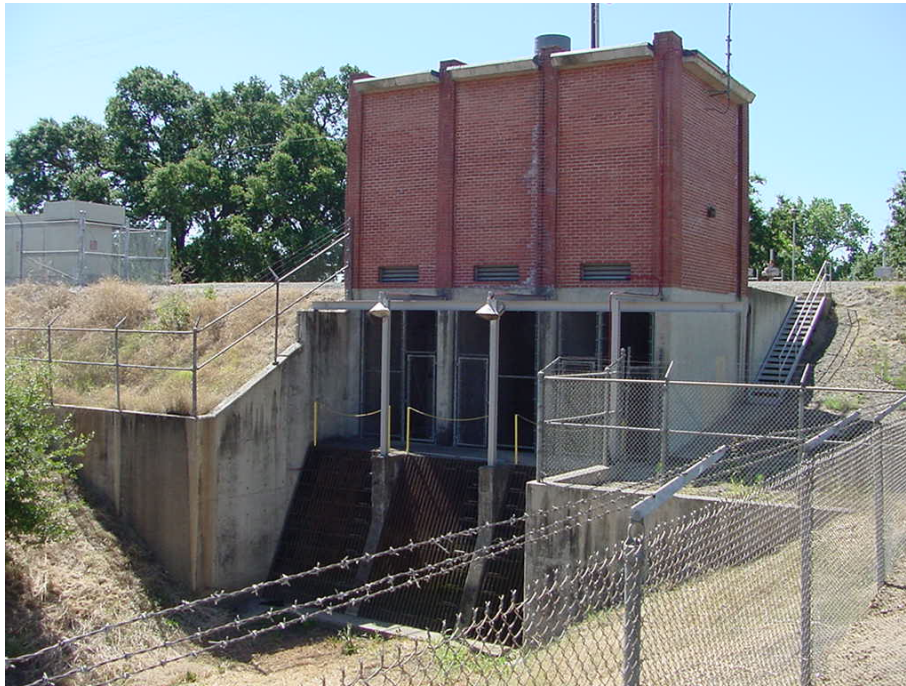
- 1. Condition of the main pump structure.**
 - a. Good.**
- 2. Condition of abutments and wing walls.**
 - a. There is a $3\frac{5}{8}$ inch deflection in the retaining wall next to the stairway on the west side of structure.**

View of the pumping plant, sump and trash racks.

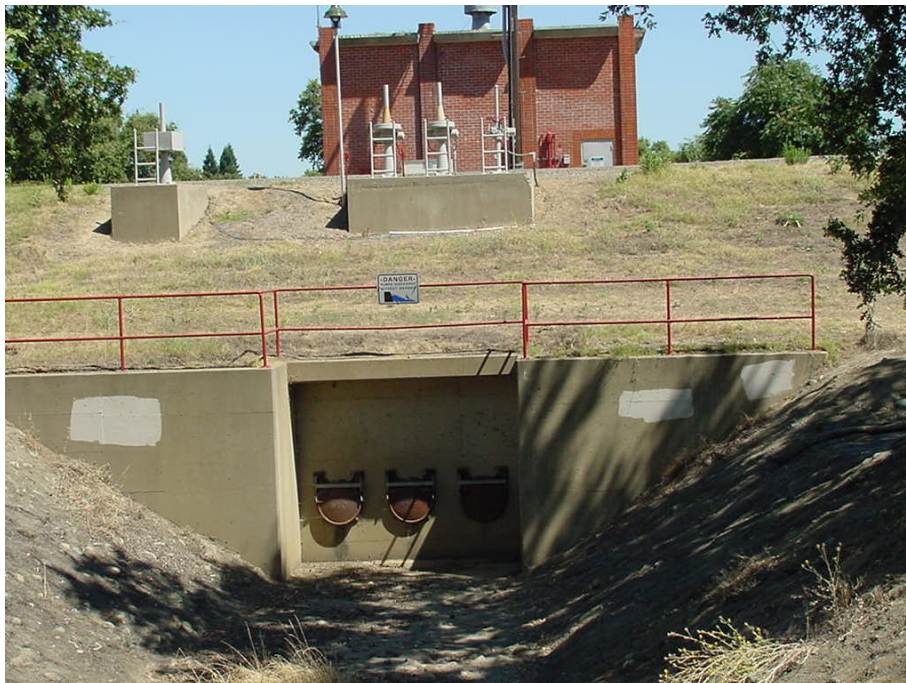
**Gate controls and flap gates on the
discharge side of the pumping plant.**

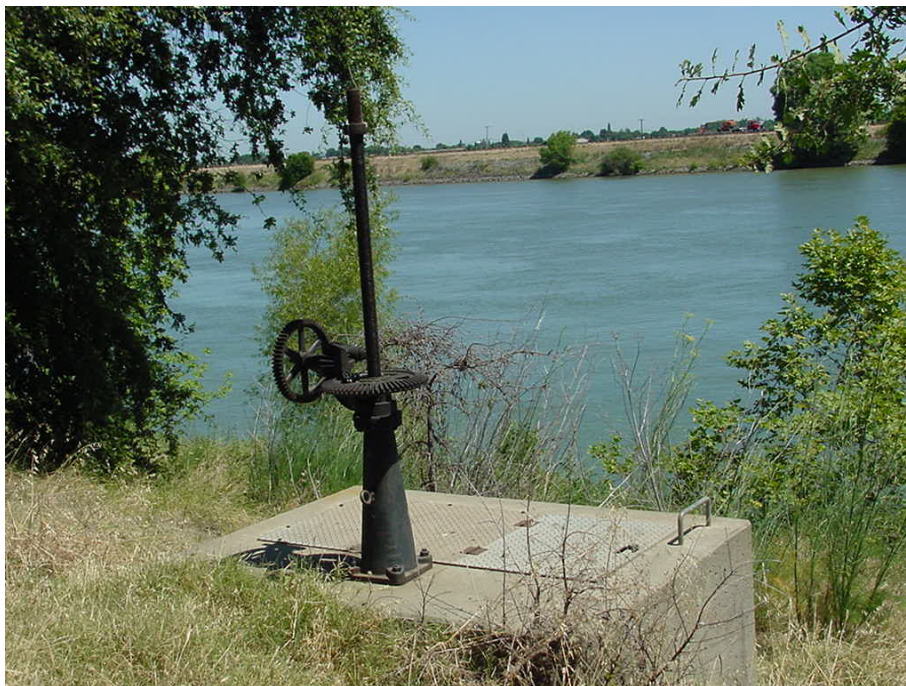
View of the gate control mechanism box.

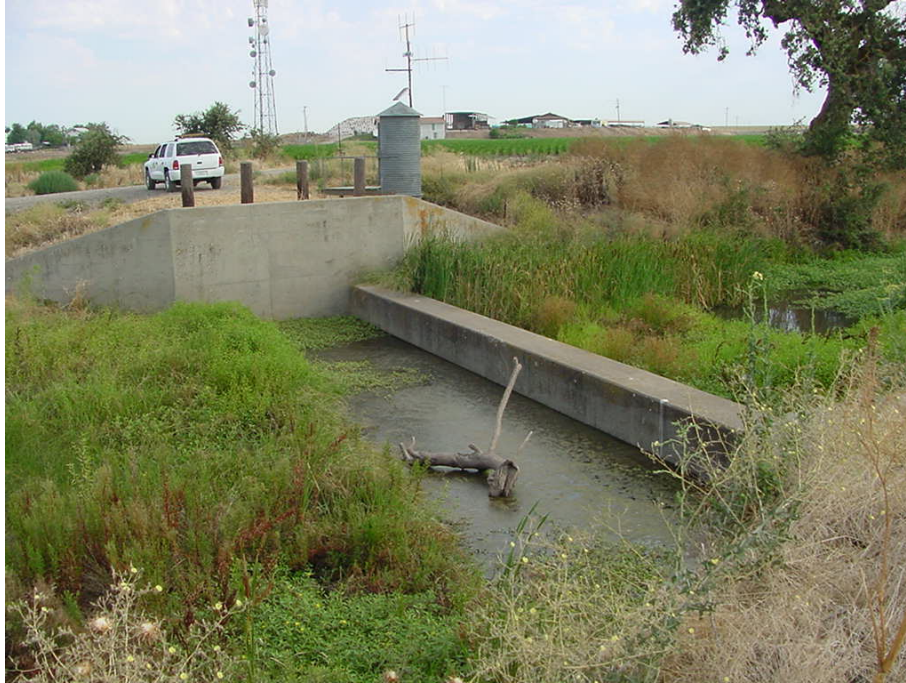
1. Condition of concrete control structure.
 - a. Good.
2. Condition of abutments and wing walls.
 - a. Good.
3. Condition of control gate and mechanism.
 - a. Good.
4. Condition of the concrete weir structure.
 - a. Good.
5. Condition of the revetment.
 - a. Good.
6. Accumulation of trash and debris around the structure or in the channel.
 - a. Good.
7. Vegetation around the structure or in the channel.
 - a. Small trees growing in the channel.
8. Comments:
 - a. Remove vegetation.
 - b. Good maintenance.

**Looking north at the weir and the
Corps of Engineers gauging house.**

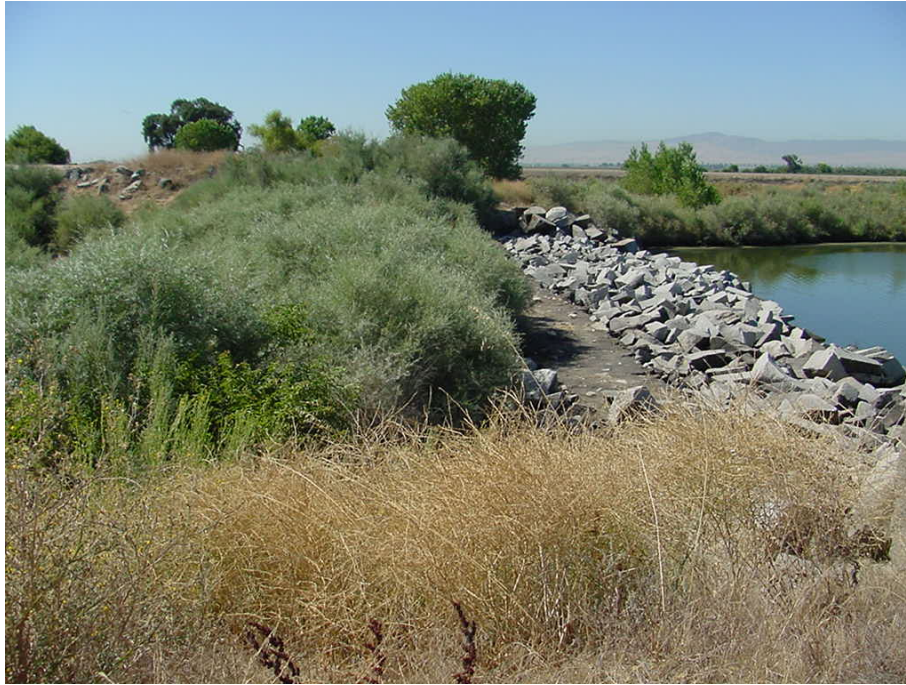
1. **Condition of the concrete rubble dam section.**
 - a. **Good.**
2. **Accumulation of trash and debris around the structure or in the channel.**
 - a. **None.**
3. **Vegetation around the structure and in the channel.**
 - a. **The willow trees along the upstream side of the structure are 12 to 15 feet tall and could alter the proper design function of the dam.**
4. **Comments:**
 - a. **Willow trees should be removed.**
 - b. **Maintenance responsibilities need to be addressed and determined.**

**Looking south at the upstream side of the dam.
Note the willow growth in front of the structure.**

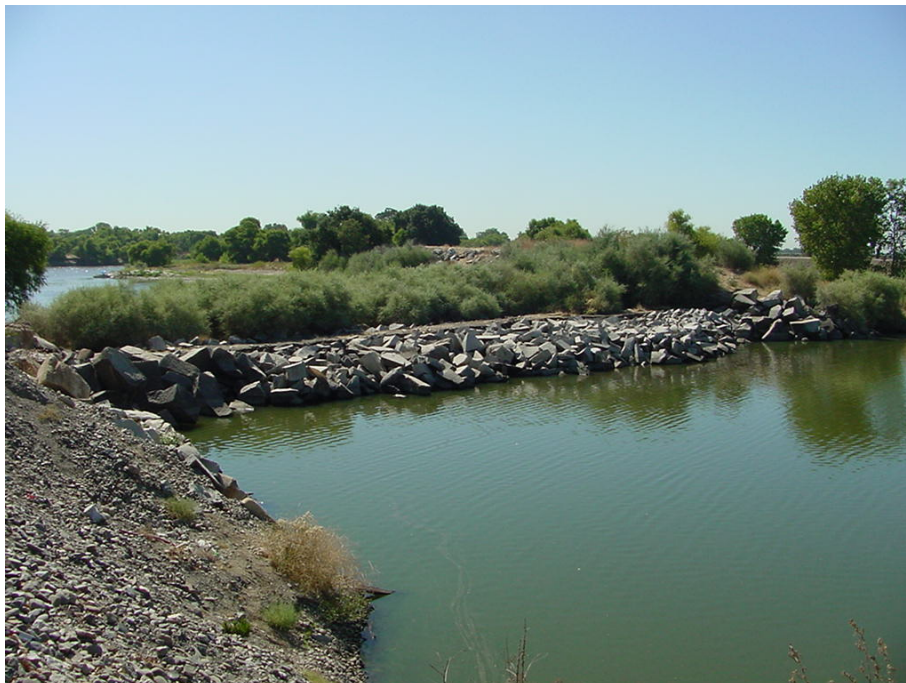
**Looking southeast at the downstream side of the structure.
The San Joaquin river is in the background.**

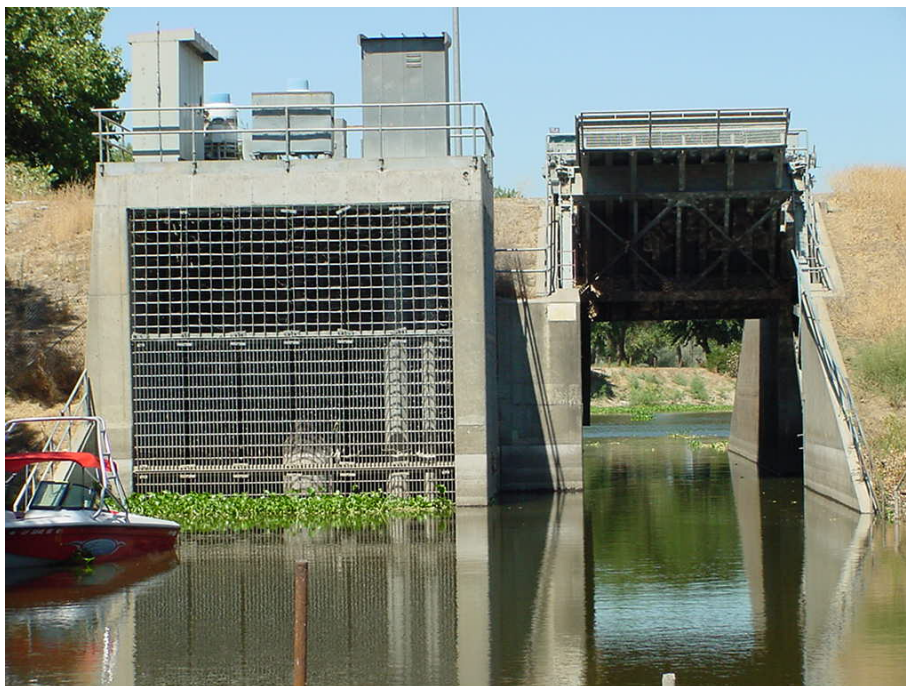
1. Condition of main pump structure.
 - a. Good.
2. Condition of the navigation gate structure.
 - a. Good.
3. Condition of the abutments and wing walls.
 - a. Good, but there is a $\frac{3}{4}$ inch separation in the joint between left retainer wall and wing wall. It has remained stable for several years.
4. Condition of pumps and motors.
 - a. Good.
5. Condition of flap gates.
 - a. Good.
6. Condition of electrical equipment.
 - a. Good.
7. Condition of the trash rack.
 - a. Good.
8. Condition of the gate hoist mechanism.
 - a. Good.
9. Condition of the revetment.
 - a. Good.
10. Accumulation of trash and debris around the structure or in the channel.
 - a. None.
11. Comments:
 - a. Good maintenance.

View of the pump house intake and the radial gate.

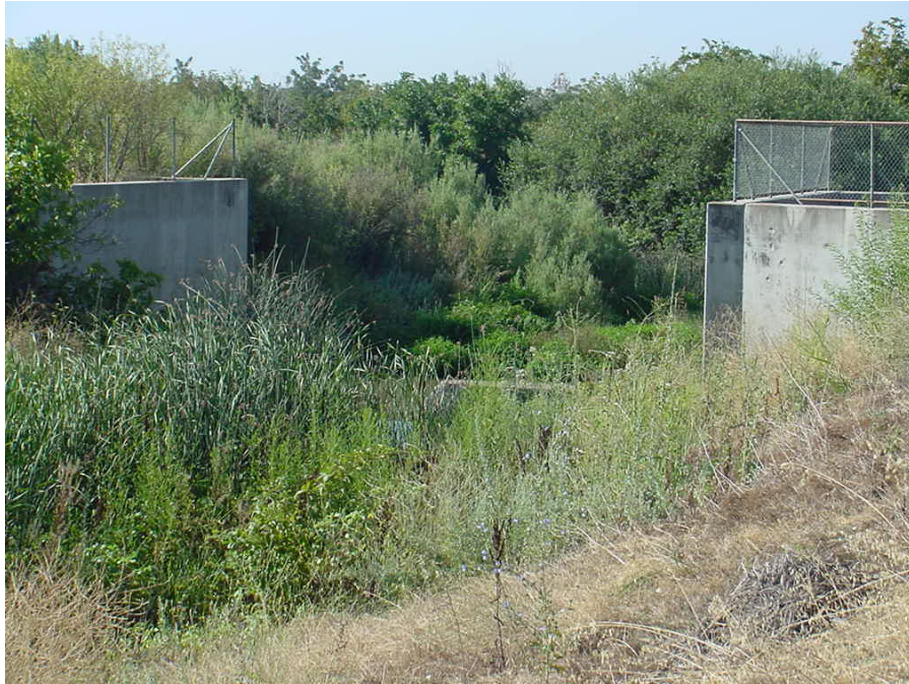
- 1. Condition of concrete drop structure.**
 - a. Good.**
- 2. Condition of concrete abutments.**
 - a. Good.**
 - b. Separation of the left bank wall is stable.**
- 3. Condition of revetment.**
 - a. Good.**
- 4. Accumulation of trash and debris around the structure or in the channel.**
 - a. None.**
- 5. Vegetation around the structure or in the channel.**
 - a. Moderate growth in the channel, upstream of the structure.**
- 6. Comments:**
 - a. Remove vegetation upstream of the structure.**
 - b. Fair maintenance.**

The upstream side of the structure.

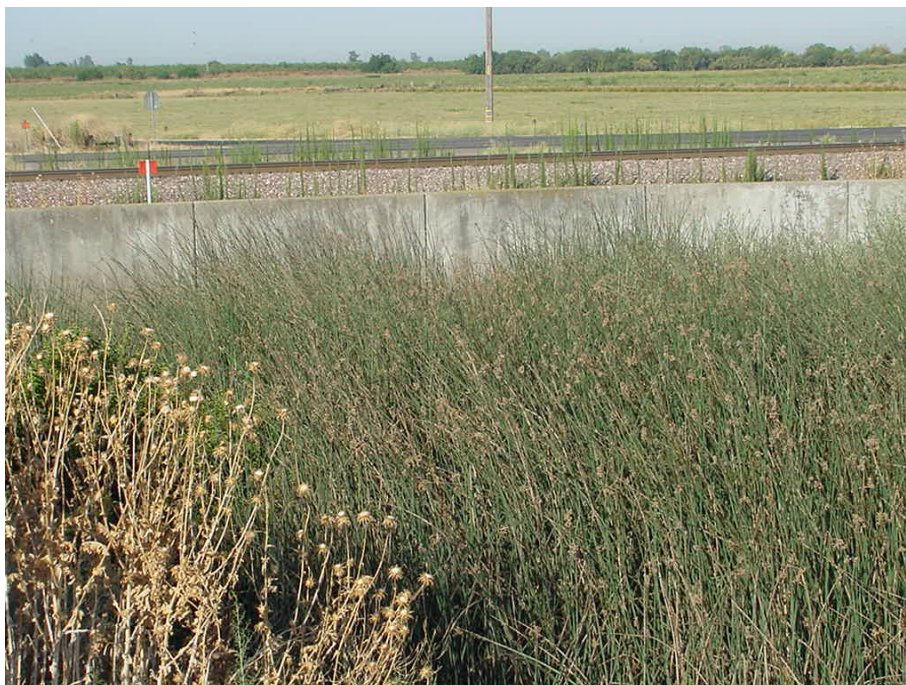
- 1. Condition of concrete siphon structure.**
 - a. Good.**
- 2. Condition of concrete abutments and wing walls.**
 - a. Good.**
 - b. Separation of the left bank wall is stable.**
- 3. Condition of revetment.**
 - a. Good.**
- 4. Accumulation of trash and debris around the structure or in the channel.**
 - a. None.**
- 5. Vegetation around the structure or in the channel.**
 - a. There is dense tule and weed growth in the channel immediately upstream and downstream of the structure.**
- 6. Comments:**
 - a. Remove weeds and tule growth. Inspection is limited due to excessive vegetation.**
 - b. Fair maintenance.**

The upstream side of the structure.

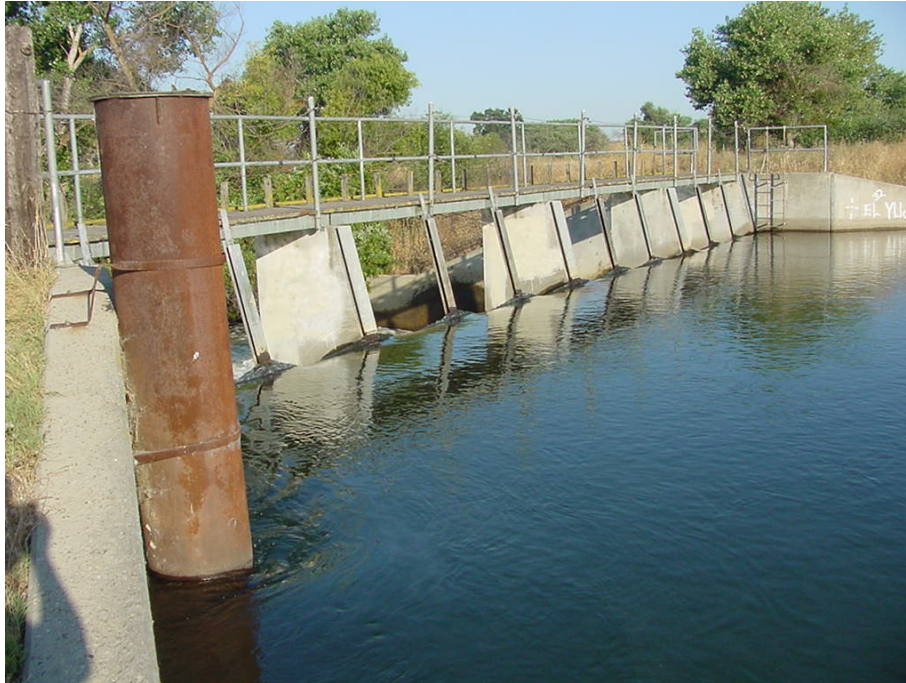
1. Condition of concrete control structures.
 - a. Good.
2. Condition of concrete abutments and wing walls.
 - a. Good.
3. Condition of stop logs and supports.
 - a. Good.
4. Condition of revetments.
 - a. Good.
5. Accumulation of trash and debris around the structures or in the channels.
 - a. None.
6. Vegetation around the control structures or in the channels.
 - a. Moderate vegetation in the channel downstream of the Ash Slough structure. (See 2005 Channel Report)
7. Comments:
 - a. Remove the vegetation from the channel and around the structure.
 - b. Good maintenance.

The upstream side of the Berenda structure.

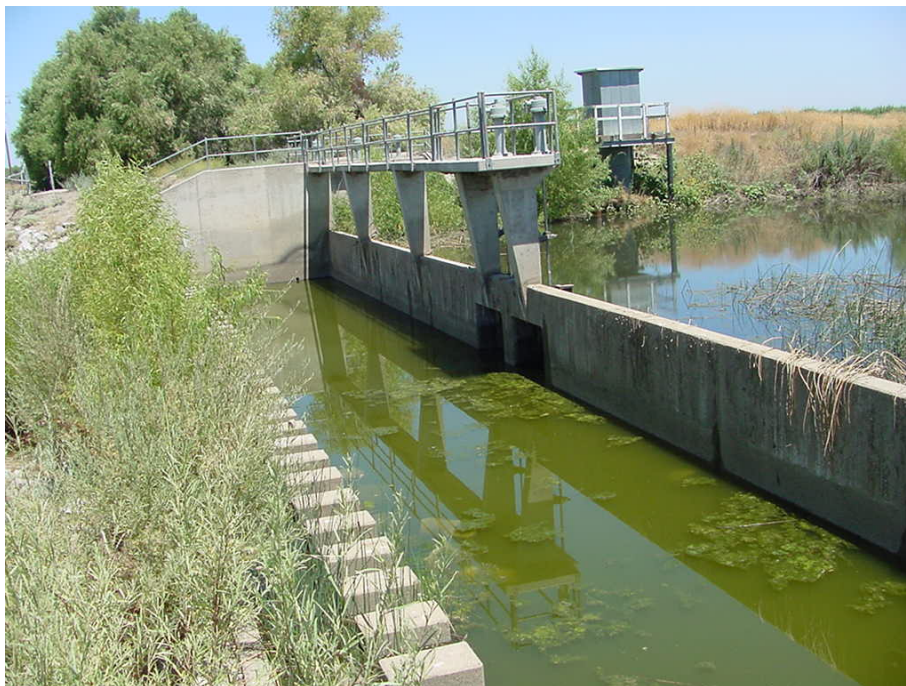
1. Condition of concrete weir structure, stilling basin, and velocity dissipaters.
 - a. Good.
2. Condition of the diversion structure.
 - a. Good.
3. Condition of the concrete abutments and wing walls.
 - a. Good.
4. Condition of control gate and mechanisms.
 - a. Good.
5. Condition of revetments.
 - a. Good.
6. Accumulation of trash and debris around the structures or in the channel.
 - a. None.
7. Vegetation around the structures or in the channel.
 - a. Moderate growth in channel and around the structure.
8. Condition of gauging house and equipment.
 - a. Good.
9. Comments:
 - a. Remove the growth from the structure and channel.
 - b. Good maintenance.

View of the velocity dissipaters, stilling basin and weir.

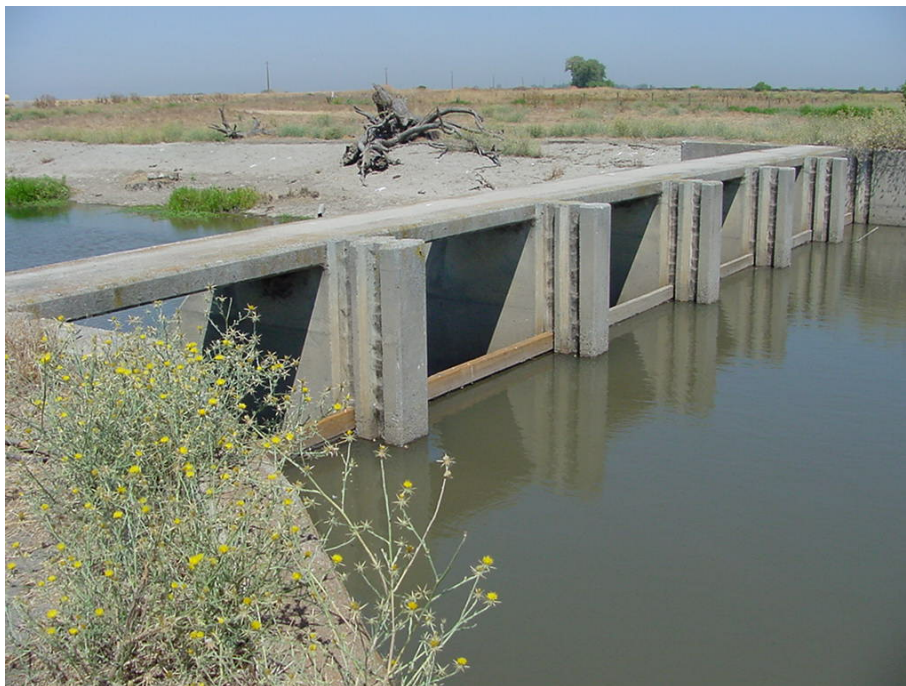
The upstream side of the structure.

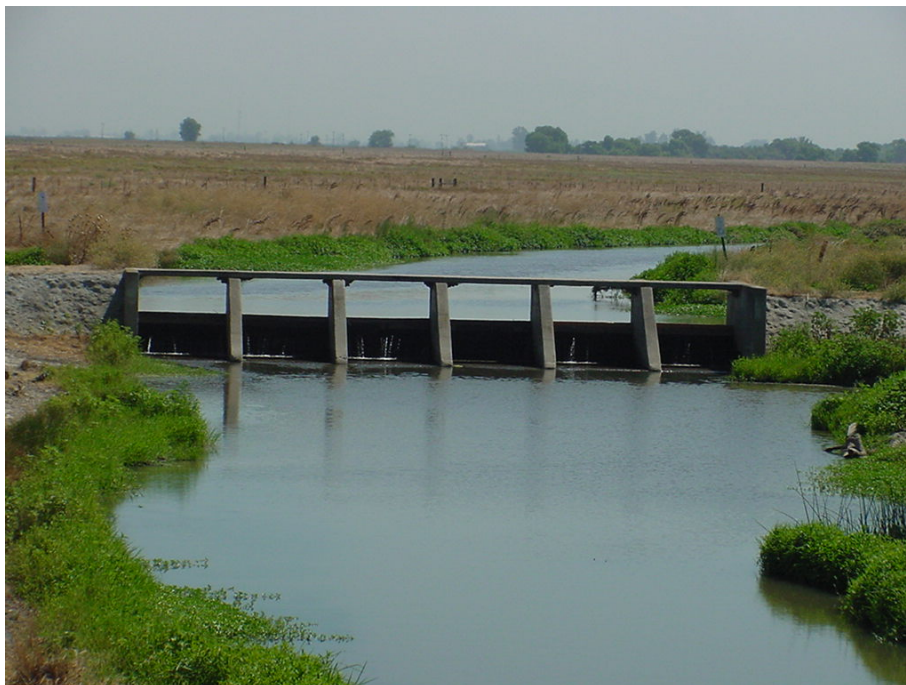
The downstream side of the structure.

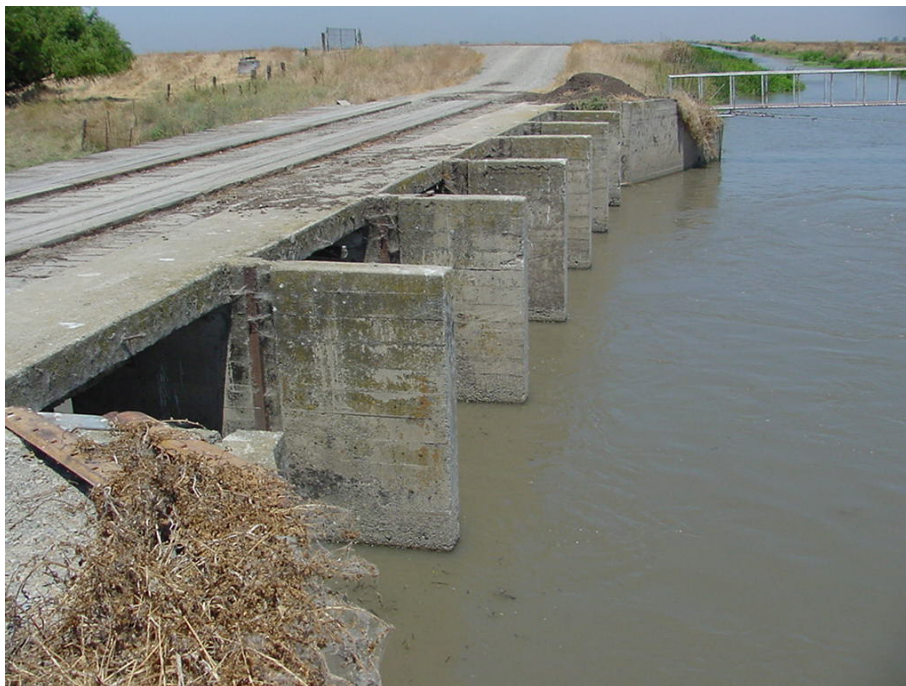
- 1. Condition of concrete control structure.**
 - a. Good.**
- 2. Condition of abutments and wing walls.**
 - a. There are 2 inch cracks, four to five feet in length in the right and left bank abutments.**
- 3. Condition of stop logs and supports.**
 - a. Good.**
- 4. Accumulation of trash and debris around the structure or in the channel.**
 - a. None.**
- 5. Vegetation around the structure or in the channel.**
 - a. Minimal.**
- 6. Comments:**
 - a. This structure was in existence prior to the construction of the project and is a part of the Lower San Joaquin Levee District but is operated by Eastside Canal Company.**
 - b. Monitor and repair the cracks in the abutments as needed.**
 - c. Fair maintenance.**
 - d. Wooden bridge crossing has new timber, replaced by L.S.J.L.D.**

The upstream side of the structure.

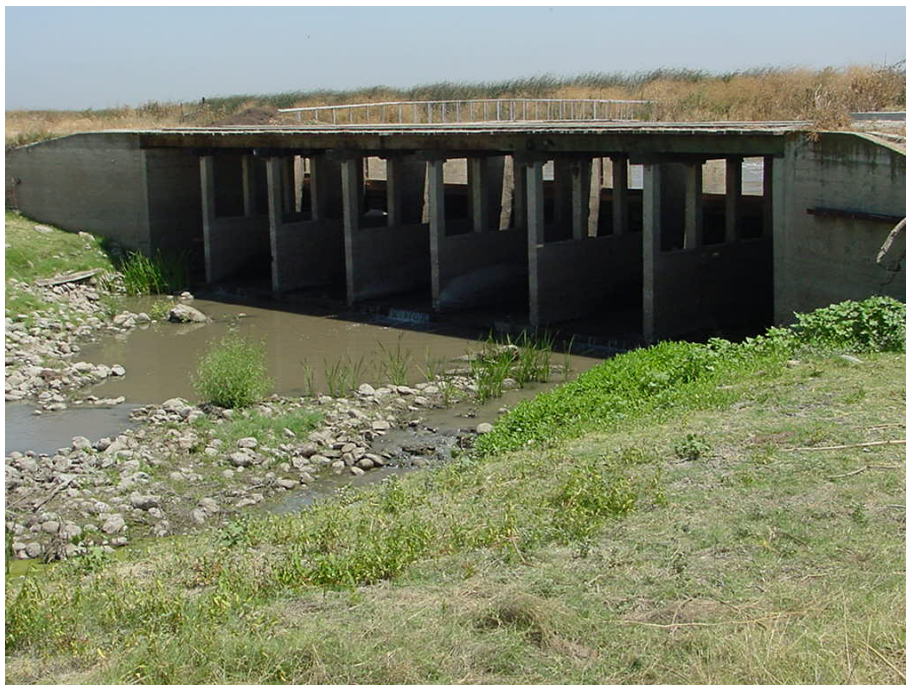
The downstream side of the structure.

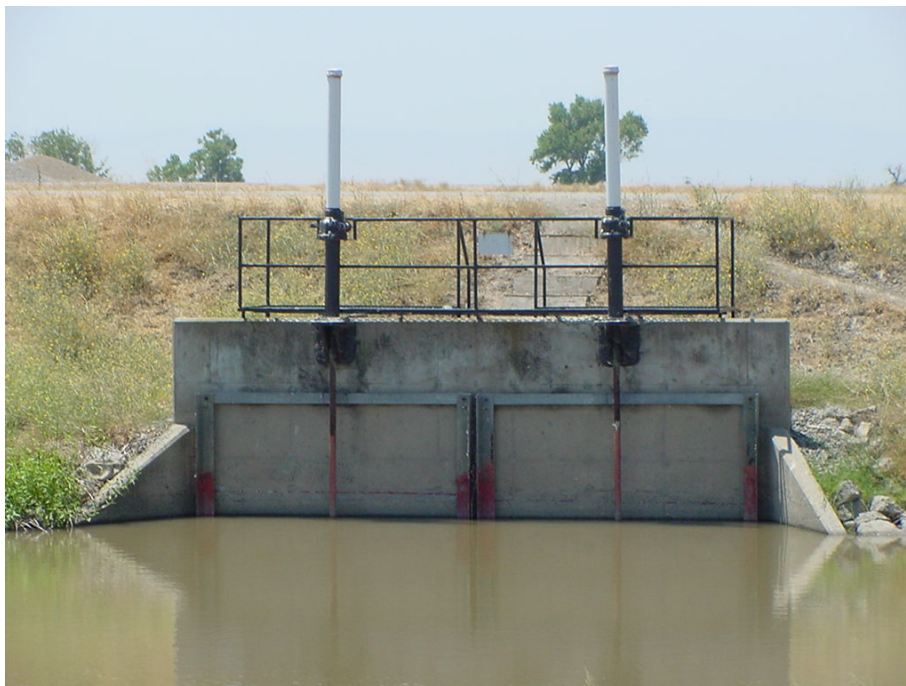
View of the two 72 inch slide gates at the intake side of the structure.

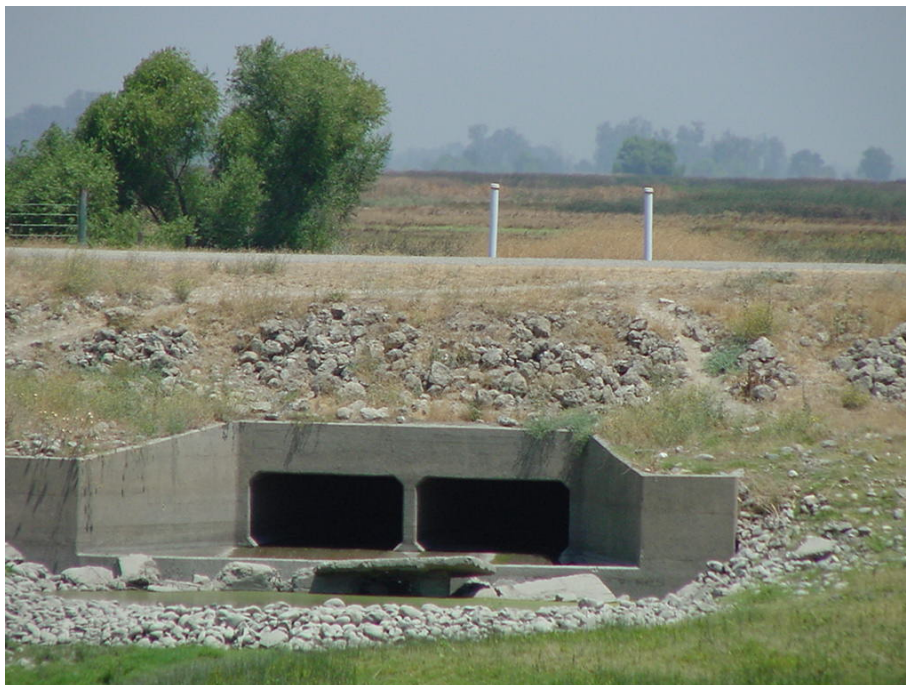
View of the discharge side of the structure into the Eastside Bypass.

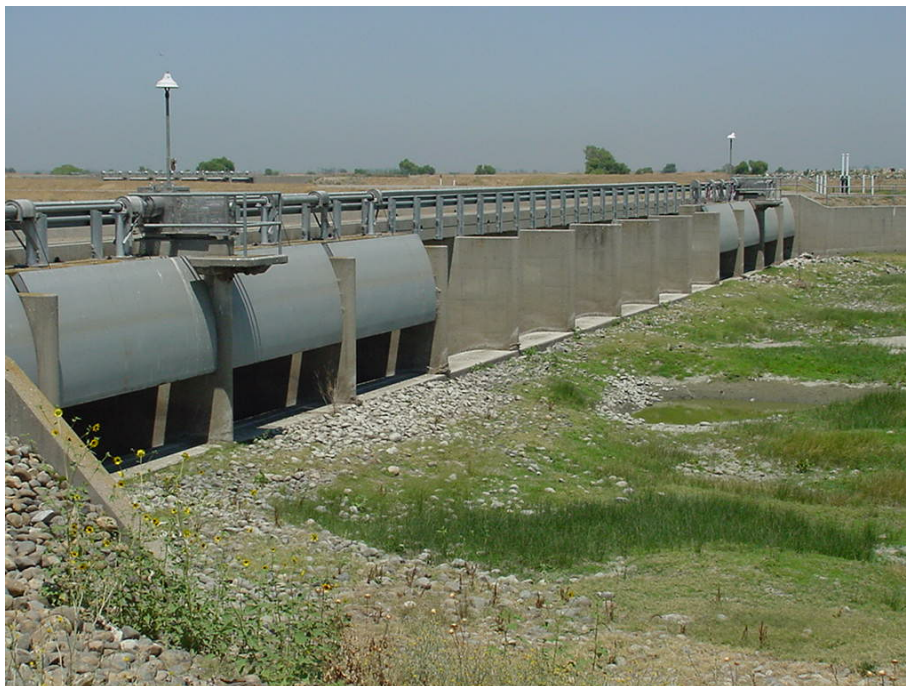
The upstream side of the structure.

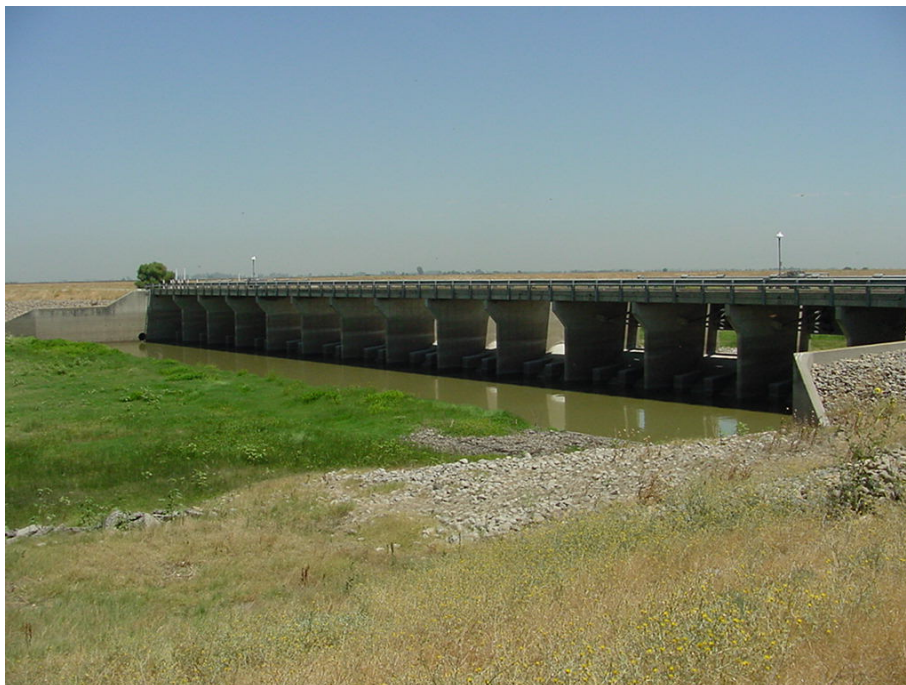
The downstream side of the structure.

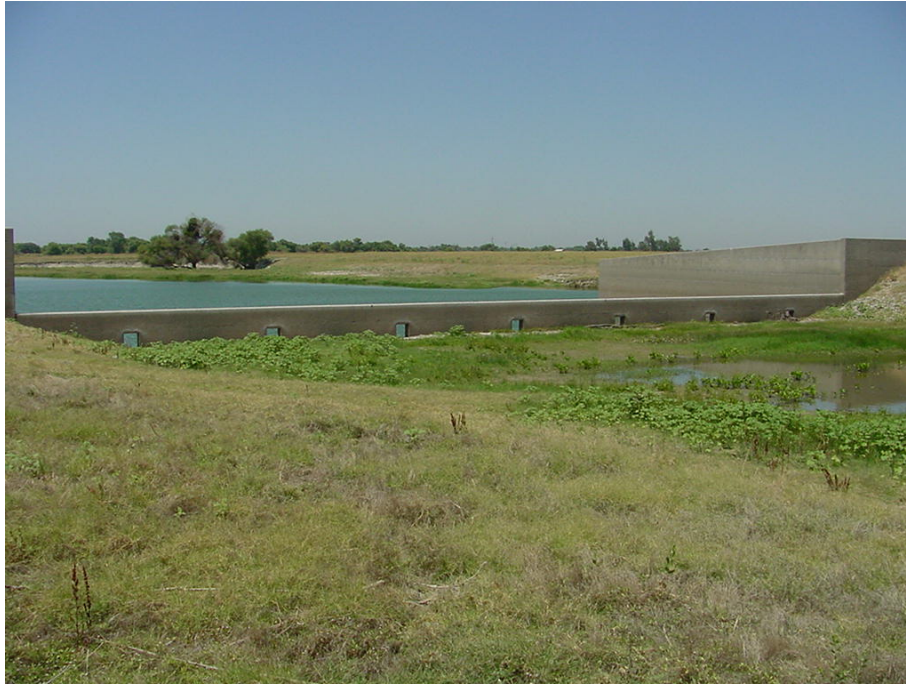
1. Condition of concrete drop structure, stilling basin, and velocity dissipaters.
 - a. Good.
2. Condition of concrete abutments and wing walls.
 - a. The left wing wall has a 3 inch separation at the joint but appears to be stable.
3. Condition of revetment.
 - a. Good.
4. Accumulation of trash and debris around the structure or in the channel.
 - a. None.
5. Vegetation around the structure or in the channel.
 - a. None.
6. Comments:
 - a. Monitor the left wing wall during high water.
 - b. Good maintenance.

The upstream side of the structure.

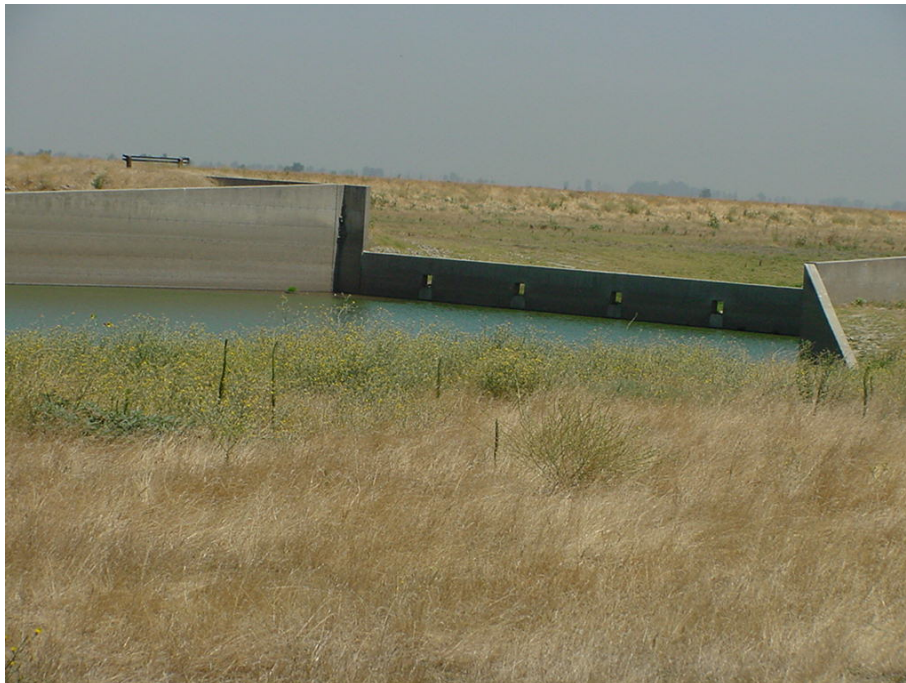
The downstream side of the structure .

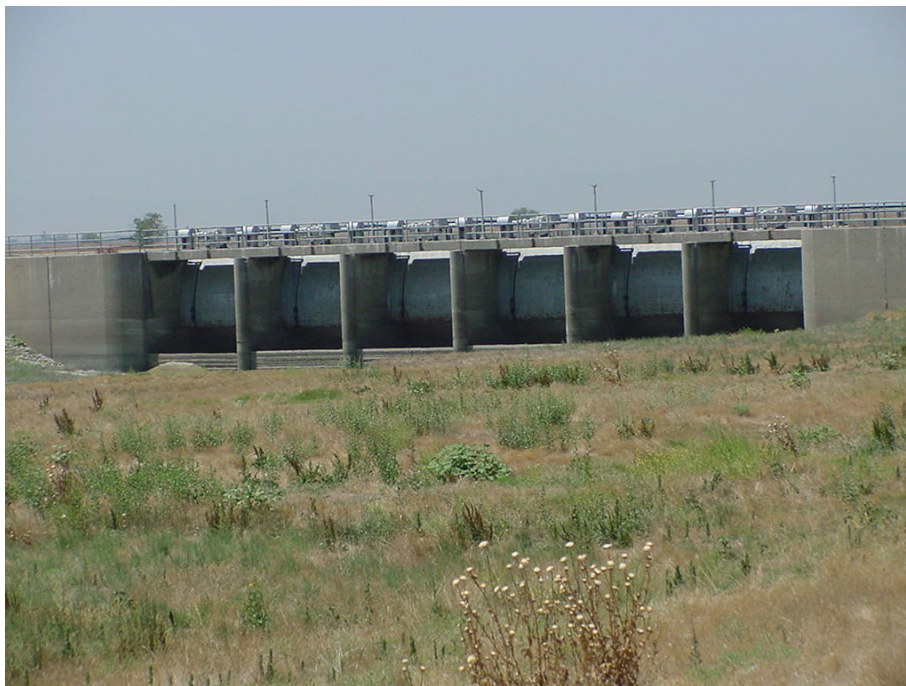
The upstream side of the structure.

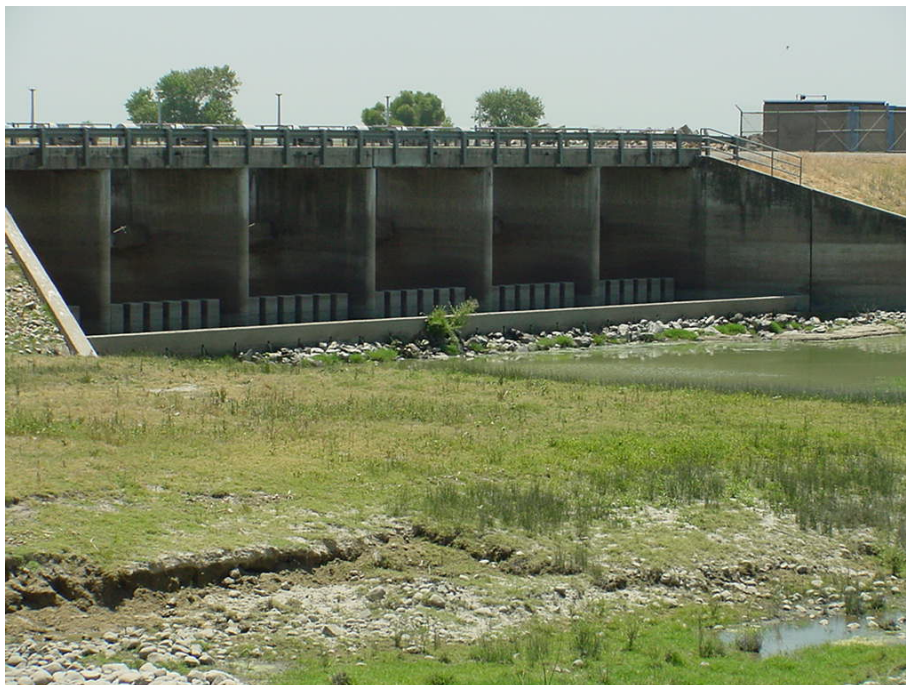
The downstream side of the structure.

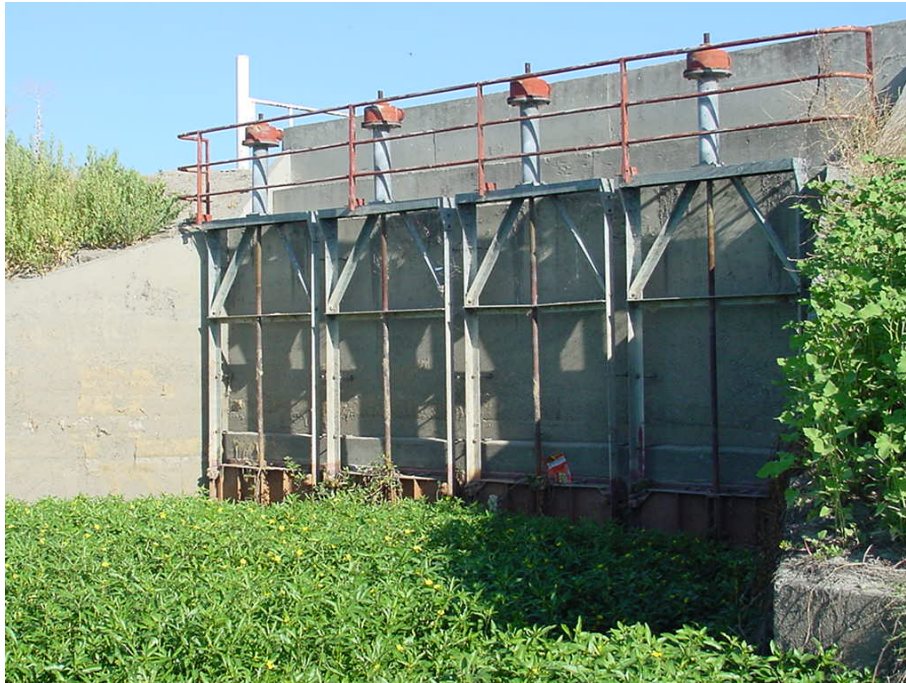
View of the control gates at the intake of the structure.

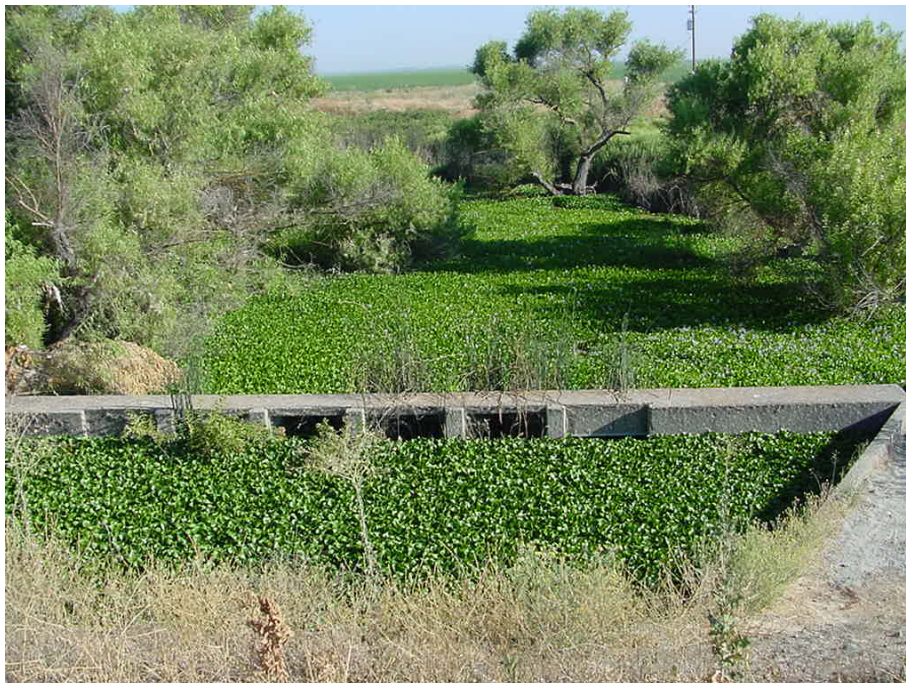
View of the outlet channel.

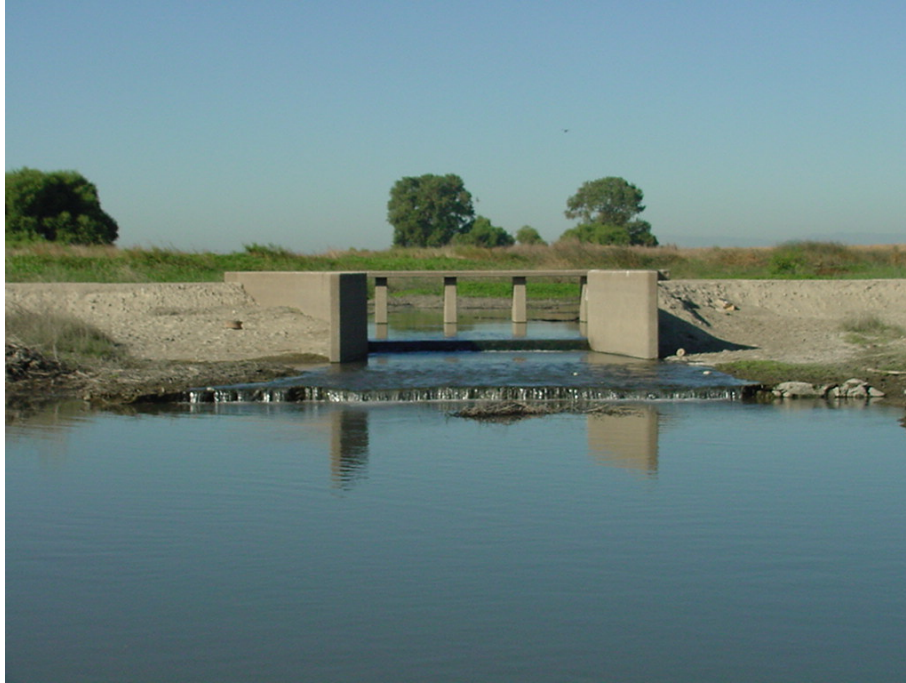
Looking upstream at the Sand Slough structure.
